TITLE: SURFACE CHARACTERIZATION OF LDEF MATERIALS

TYPE: FINAL TECHNICAL REPORT

SURFACE CHARACTERIZATION OF LDEF MATERIALS

* This final technical report is based wholly on the M.S. thesis of Holly Little Grammer in Chemistry (1993).

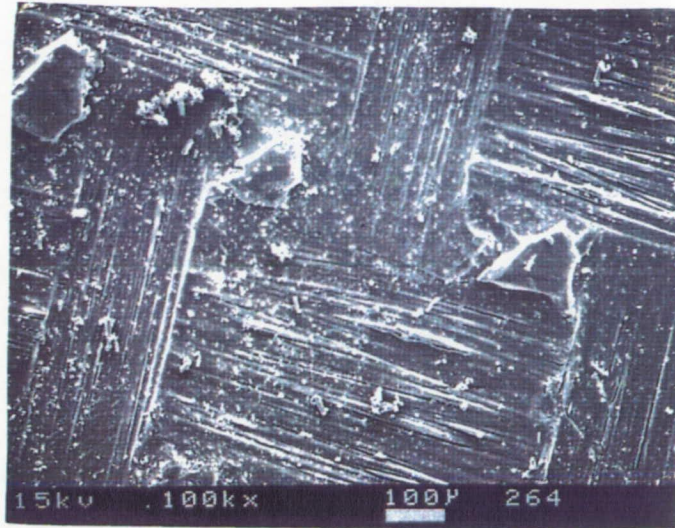
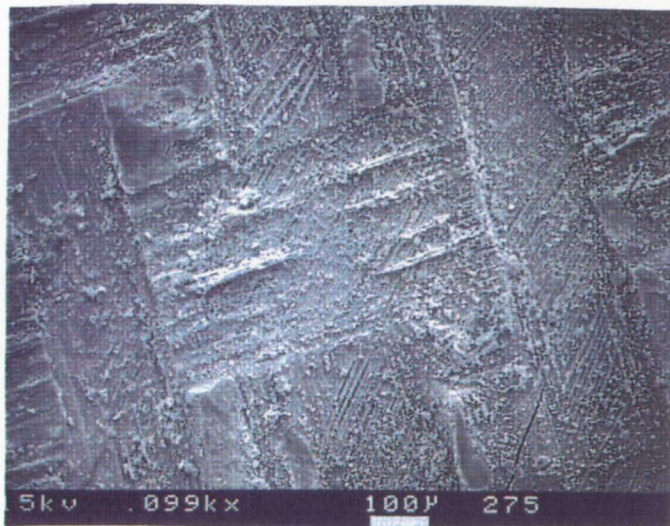
FIGURE 4.21: SEM PHOTOMICROGRAPHS OF 934/T300 COMPOSITE SAMPLES (A) CONTROL (B) 10 MONTH (C) 69 MONTH.

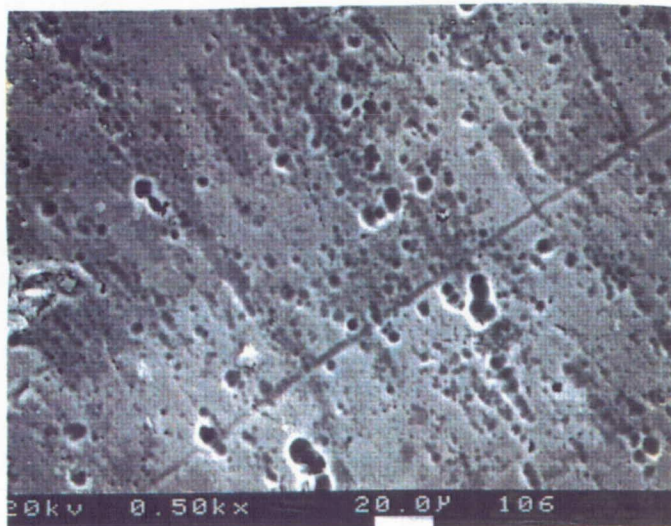
FIGURE 4.28: SEM PHOTOMICROGRAPHS OF 6061-T6 ALUMINUM SURFACE OF (A) CONTROL (B) E3-TRAILING EDGE (C) D9-LEADING EDGE TRAY CLAMPS.
